## Case Study: Exterior Application of Madewell's Crack-Bridging Laminate System in Albany, IN

**Contractor:** Culy Contracting, Inc.  
**Location:** Albany, Indiana  
**Structure:** 6,000 square foot concrete brine tank  
**Year:** 2005, 2013

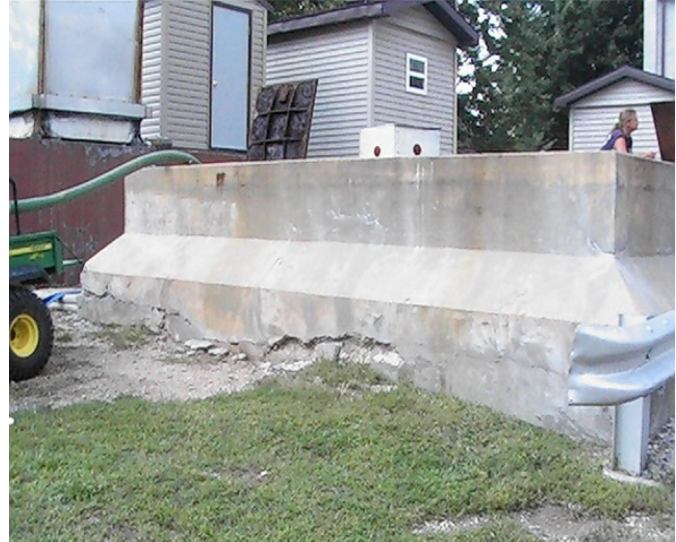
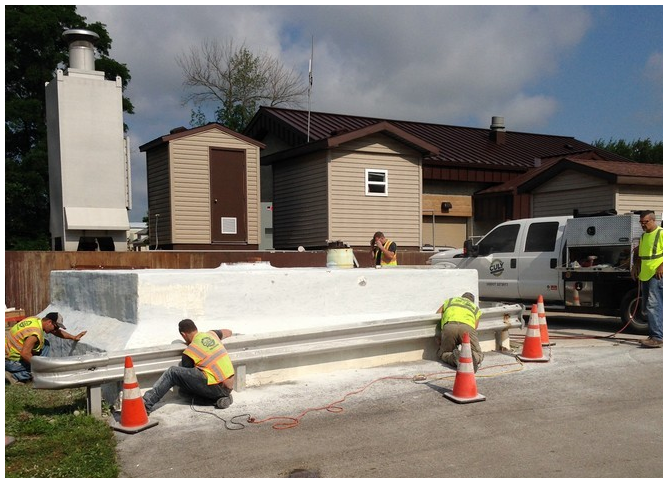
In 2005, a concrete brine tank in the city of Albany, Indiana was very badly deteriorated and in desperate need of repair. Culy Contracting had recently performed manhole rehabilitation work for the city and agreed to restore the brine tank as well. The crew began interior restoration by using a vacuum truck to remove all media and other debris from the bottom of the tank. Then, surface preparation was performed with a pressure washer, and the leftover debris was again vacuumed out of the tank. The concrete substrate was dampened with water to provide a saturated surface needed for the application of Mainstay ML-72 Sprayable Microsilica Restoration Mortar. The mortar was applied to the walls using shotcrete equipment at 3/4" and finished using a sponge to achieve a surface profile suitable for the application of a protective coating. Mainstay DS-5 100% Solids Epoxy Coating was then sprayed over the uncured mortar at 80 mils. This process was repeated on the exterior of the tank.

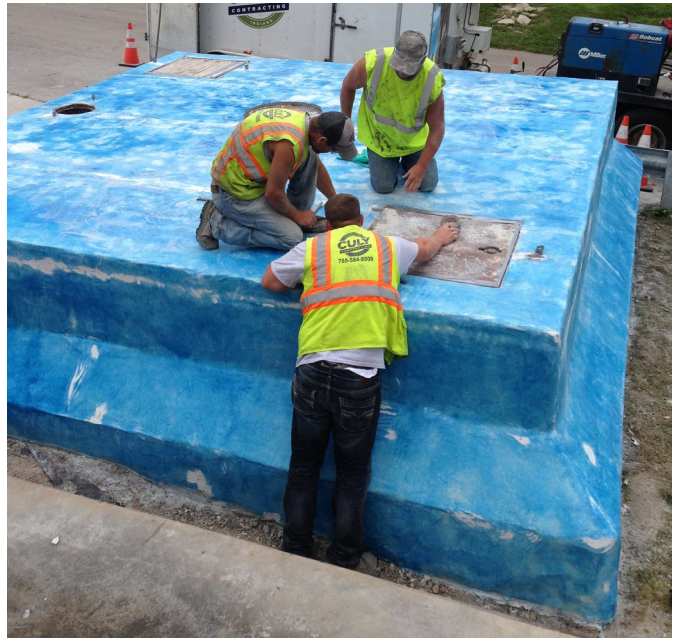
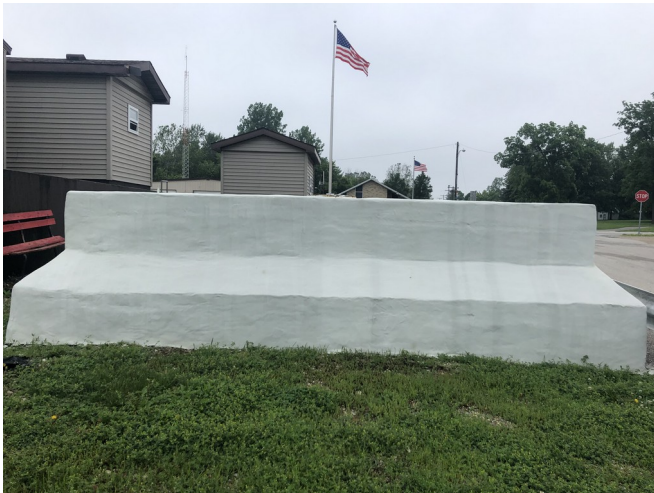
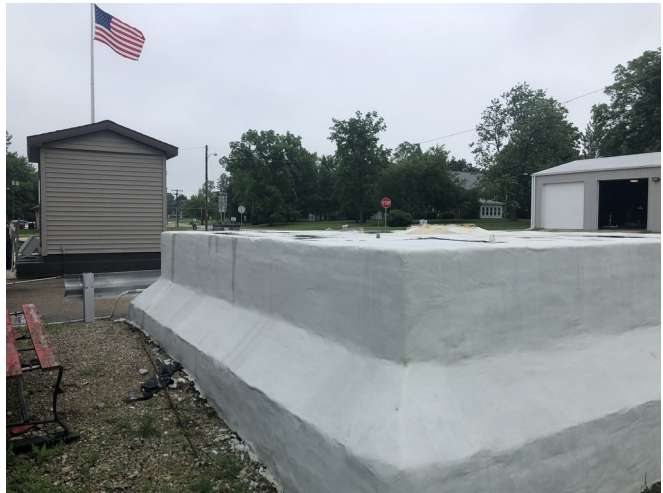
Over the years, the exterior of the brine tank underwent numerous freeze/thaw cycles. This resulted in more cracking on the outside of the tank, and in 2013, Culy Contracting was brought in to resolve the issue. The crew began by using a grinder to roughen the surface and remove any loose material. After surface preparation, a thick coat of Madewell 1312P Epoxy Putty was applied to bridge the existing cracks and smooth the substrate. One layer each of fiberglass mat and cloth were laid over the wet Madewell 1312P using rollers to remove any air voids between the

The tank was reinspected in June of 2019. The utilities department head said the lining was holding up well and reported no further issues.

epoxy and fiberglass layers. The fiberglass was then saturated with Madewell 1312E Epoxy Saturant (Resin) using a paint roller. The lining was left to cure overnight.

The next morning, any loose fiberglass strands were removed using a grinder. Denatured alcohol was used to wipe away contaminants that may have formed on the surface overnight. Then, Mainstay DS-5 Epoxy Coating was applied at 60 mils to cover the fiberglass.
