Case Study: Application of Mainstay Composite Liner FR for Protection Against Freeze/Thaw

Location: Parker City, IN

Structure: concrete clarifier

Date: May 2017

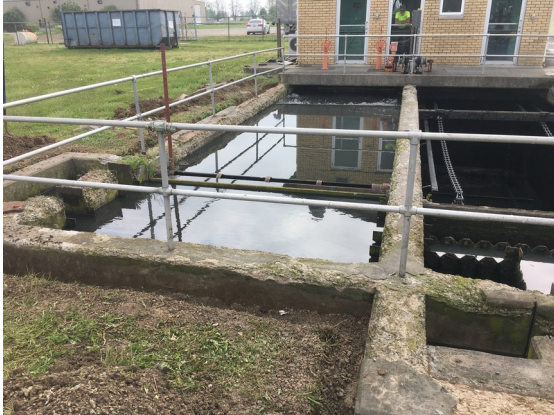
Culy Contracting, Inc. performed an application of the Mainstay Composite Liner FR on a concrete clarifier in need of repair. The above ground portion of the structure had degraded after experiencing numerous freeze/thaw cycles and long term exposure to the elements. Fragmented pieces of concrete were found stuck in sludge pumps resulting in unnecessary maintenance and decreased efficiency. The Mainstay FR system was used to restore the concrete surface and protect the structure from cracking and future deterioration.

Culy began by removing dirt both six inches down and six inches out from the exposed concrete to allow enough space to terminate the system. They performed surface preparation by pressure washing the concrete to remove loose and contaminated material. Then, Mainstay ML-72 Sprayable Microsilica Restoration Mortar was used to build back the surface where concrete had been removed. The mortar was left to cure overnight.

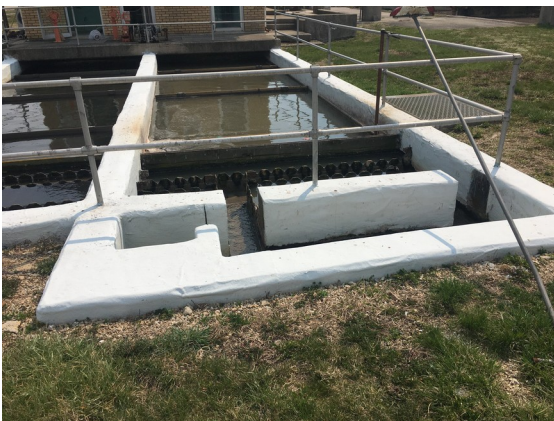
Culy's crew came back the next day to apply Madewell 927 Penetrating Epoxy Primer to the cured mortar. The primer was allowed to tack, and the crew applied a thin coat of Mainstay DS-5 100% Solids Epoxy Coating. The fiberglass reinforcement was then installed using fiberglass mat and cloth laid onto the wet epoxy and saturated with Madewell 1312E Epoxy Saturant. The material was left to cure overnight.

Upon returning the next day, the crew sanded the fiberglass layer to prep the surface for an epoxy topcoat and to remove any fiberglass strands sticking up from the surface. Lastly, a topcoat of Mainstay DS-5 Epoxy was applied to seal the fiberglass system, provide a smooth, continuous surface, and prevent any future concrete deterioration.
