## Case Study: Application of Mainstay ML-72 Mortar to 10,000 SF of Equalization Basin

**Contractor:** Culy Contracting, Inc. **Location:** Longmont, Colorado **Structure:** concrete equalization basin **Date:** June 2018

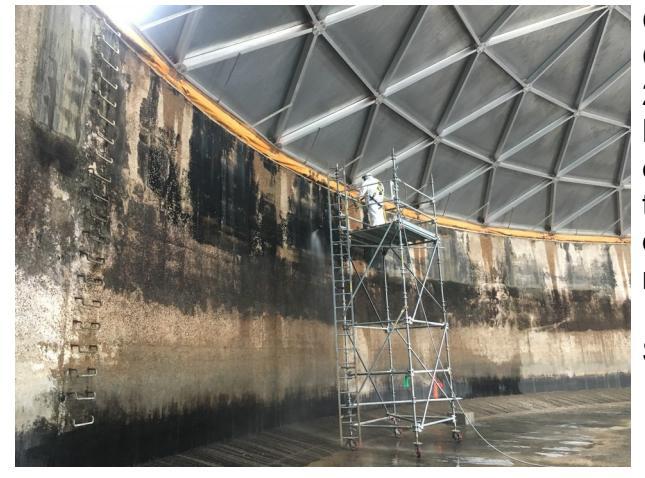
Culy Contracting, Inc. completed a project for the City of Longmont in Colorado that utilized over 2,500 bags of Mainstay ML-72 Sprayable Microsilica Restoration Mortar. A crucial concrete equalization basin at the City's wastewater treatment plant had experienced severe corrosion due to high levels of hydrogen sulfide gases. To repair the structure, Culy was contracted to apply 1.5" of Mainstay ML-72 to approximately 10,000 SF of the basin's concrete walls.

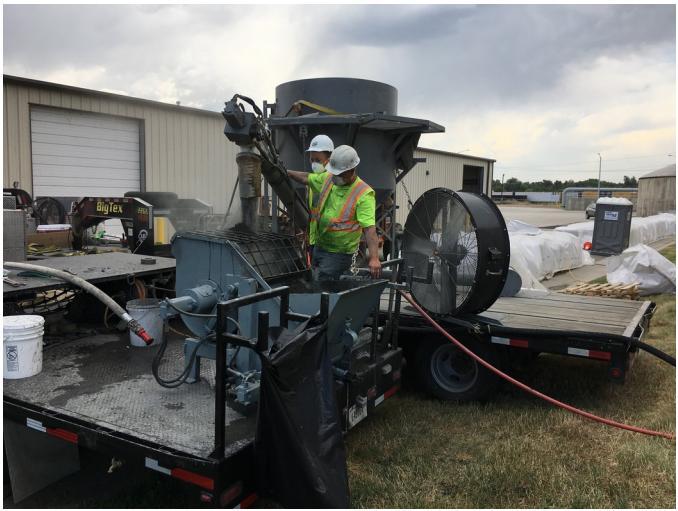
Using a telescopic loader, super sacks of mortar were loaded into the silo, which was mounted on a separate trailer from the mortar mixer. This allowed the auger to move over the mixer and back out of the way and provided easier access for the mixer operator. Mortar was pumped 125 feet

through 1.25" hose for 96 hours nonstop using the robust Madewell Mortar Mixer. The rotor and stator were replaced twice during mortar application due to wear and tear.

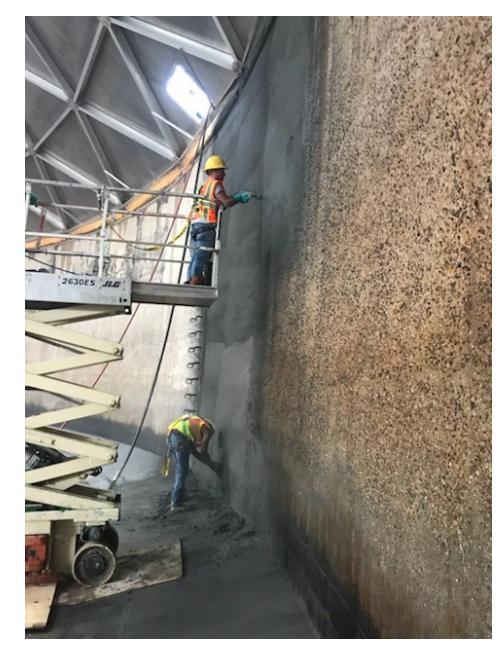
Mainstay ML-72 mortar was applied in 6-foot-wide sections at 1.5" thick using Madewell shotcrete equipment and scissor lifts. Each section was dampened with water prior to mortar application. The mortar was hand troweled smooth and broom finished to achieve a slightly textured surface. After finishing, a water-based concrete sealer was applied to prevent cracking.
